# TEST REPORT

## Chemical resistance of materials

Protocol No. ....: 6048-17-GG-17-PP001

Description.....: Stainless steel sensor PSEN ma1.3-21VA (526240)  
Stainless steel sensor PSEN ma1.3-20 M12/8VA (526249)  
Stainless steel actuator PSEN ma1.3-8VA (516140)

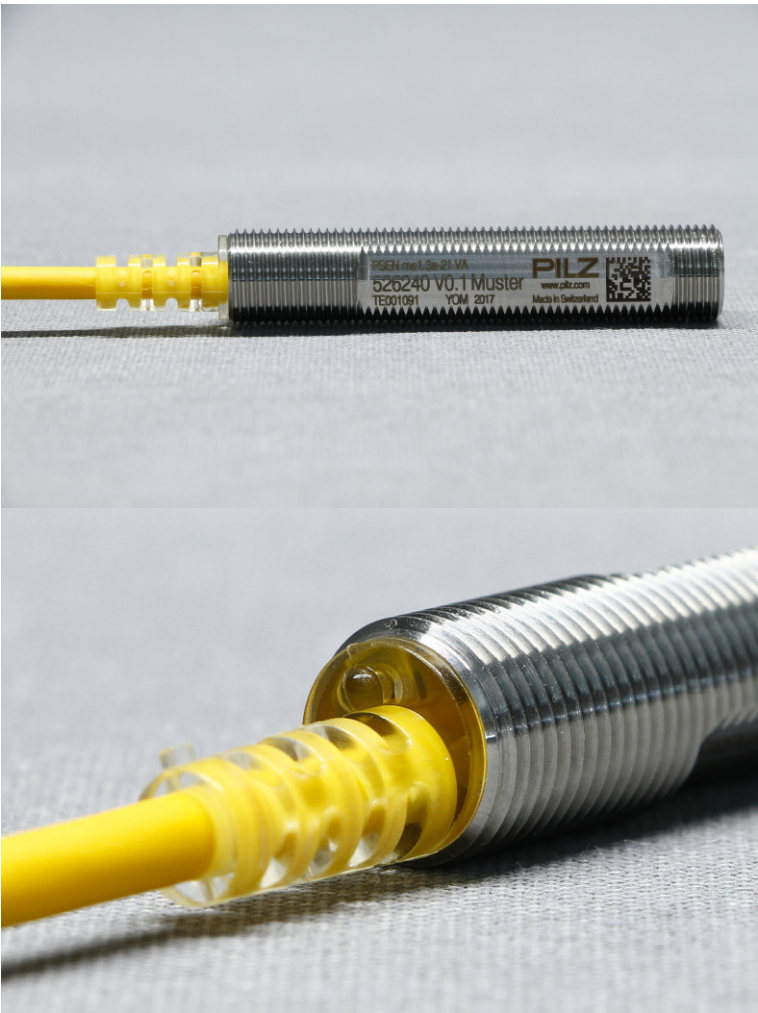
Table 3: test samples before testing

| Sample no. | Type reference: Stainless steel sensor PSEN ma1.3-21VA (526240) | | |
|---|---|--|--|
| | Samples without abnormalities. | | |

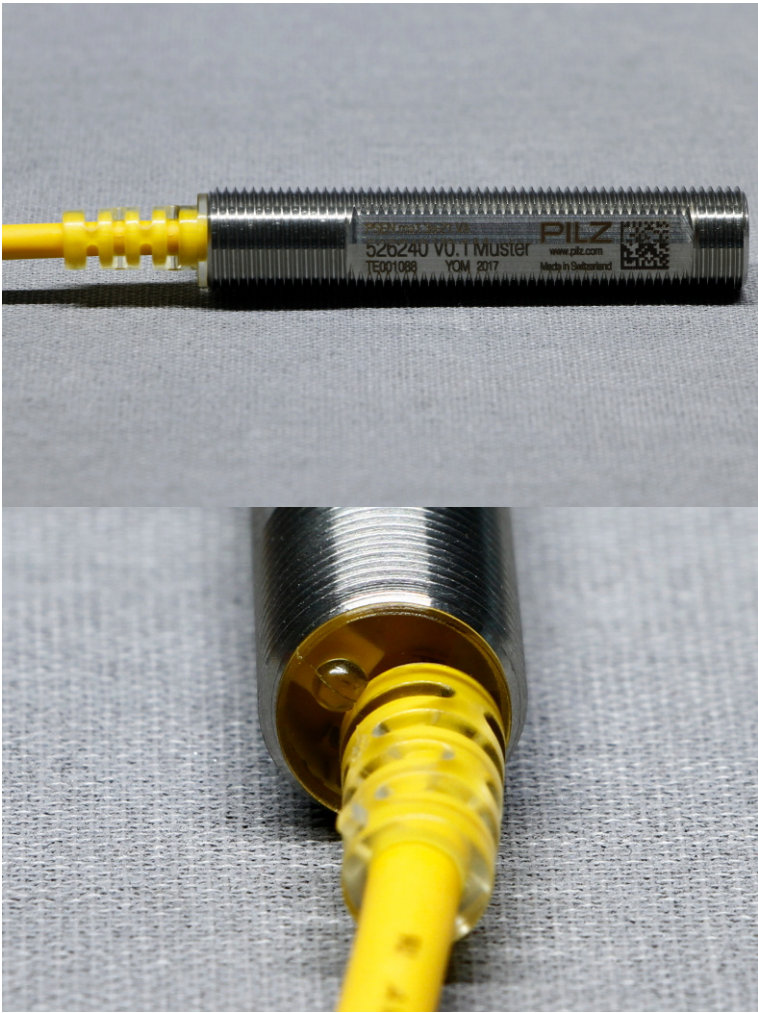
Table 4: Demineralized water

| Test medium<br>(test solution) | Demineralized water | | Result - Remark |
|---|---|--|---|
| G/006.526240 | | | <p><u>After 28 days:</u></p> <ul style="list-style-type: none"><li>- No visible abnormalities at outer enclosure parts and cable</li></ul> |

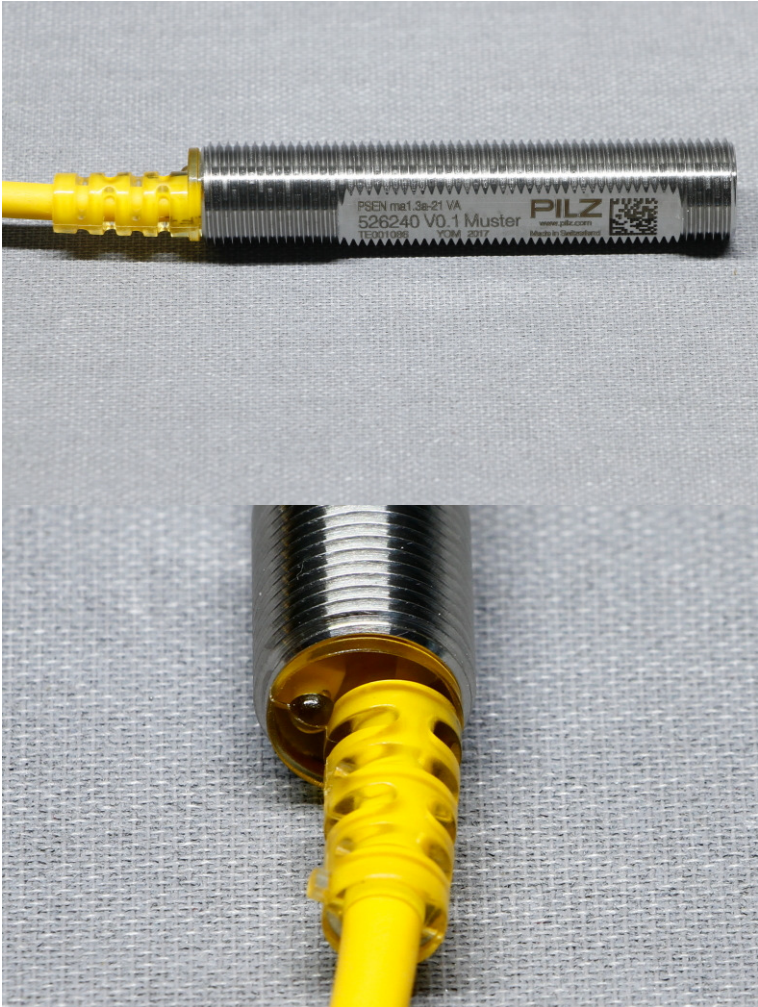
Table 5: P3-topactive OKTO

| Test medium<br>(test solution) | P3-topactive OKTO / 1% | Result - Remark |
|---|---|---|
| G/001.526240 | | <p><u>After 28 days:</u></p> <ul style="list-style-type: none"> <li>- No visible abnormalities at outer enclosure parts and cable</li> </ul> |

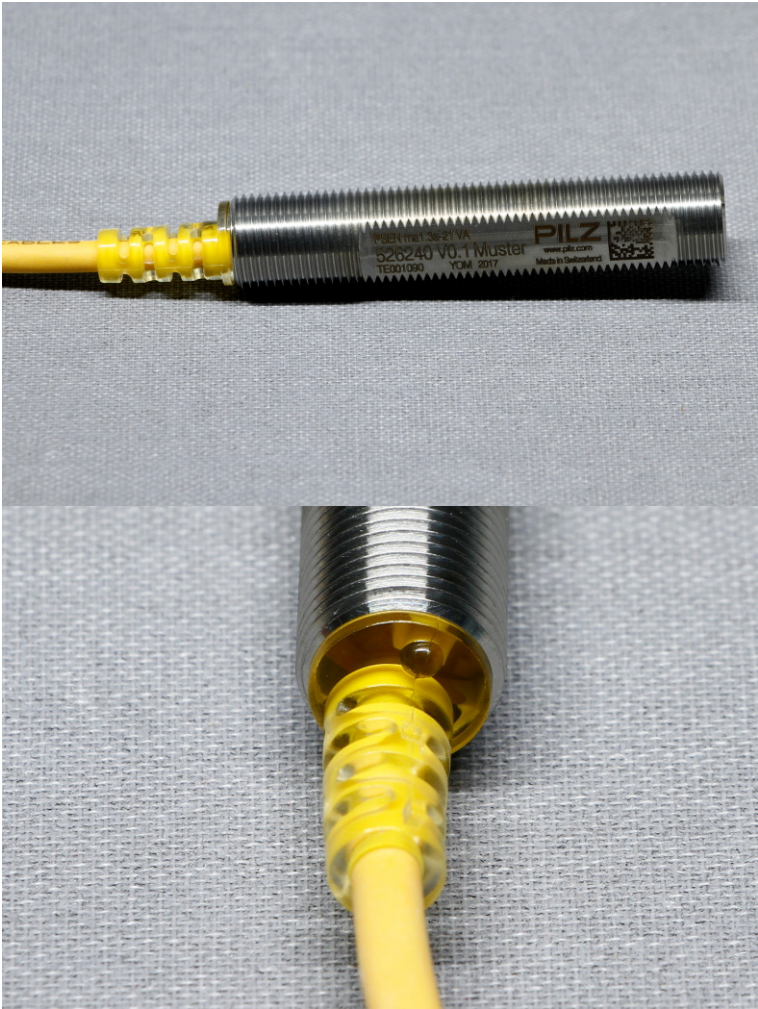
**Table 6: P3-topax 66**

| Test medium<br>(test solution) | P3-topax 66 / 5% | Result - Remark |
|---|---|---|
| G/002.526240 | | <p>After 28 days:</p> <ul style="list-style-type: none"><li>- No visible abnormalities at outer enclosure parts and cable</li></ul> |

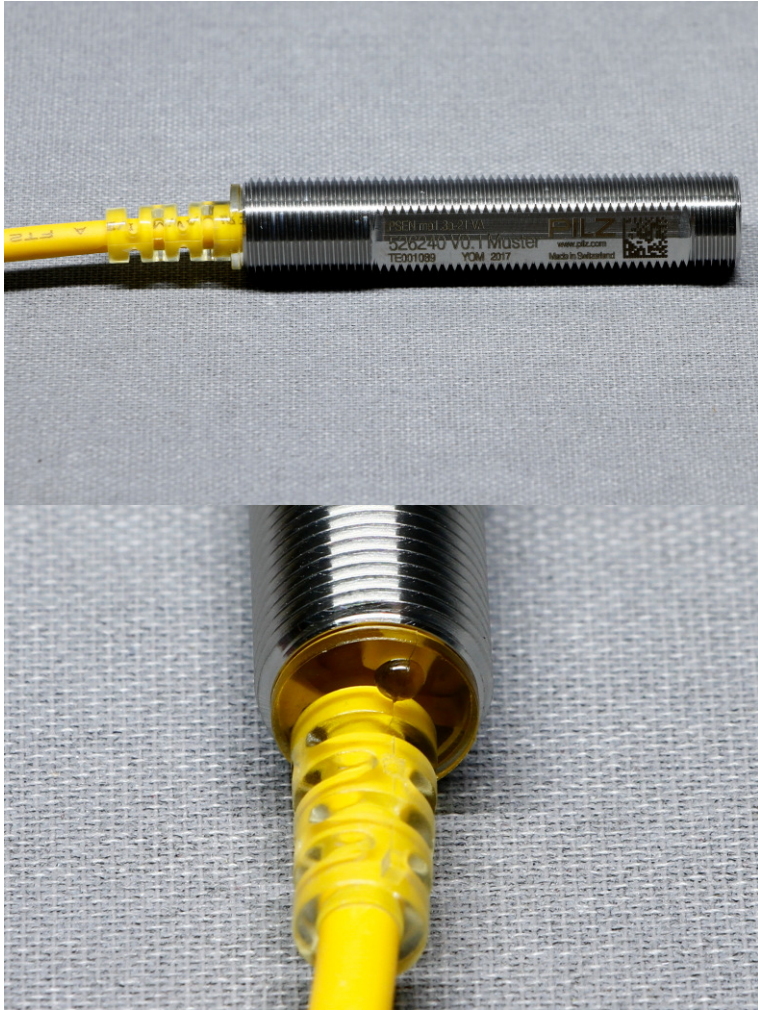
Table 7: P3-topactive 200

| Test medium<br>(test solution) | P3-topactive 200 / 5% | Result - Remark |
|---|---|---|
| G/003.526240 | | <p>After 28 days:</p> <ul style="list-style-type: none"> <li>- No visible abnormalities at outer enclosure parts and cable</li> </ul> |

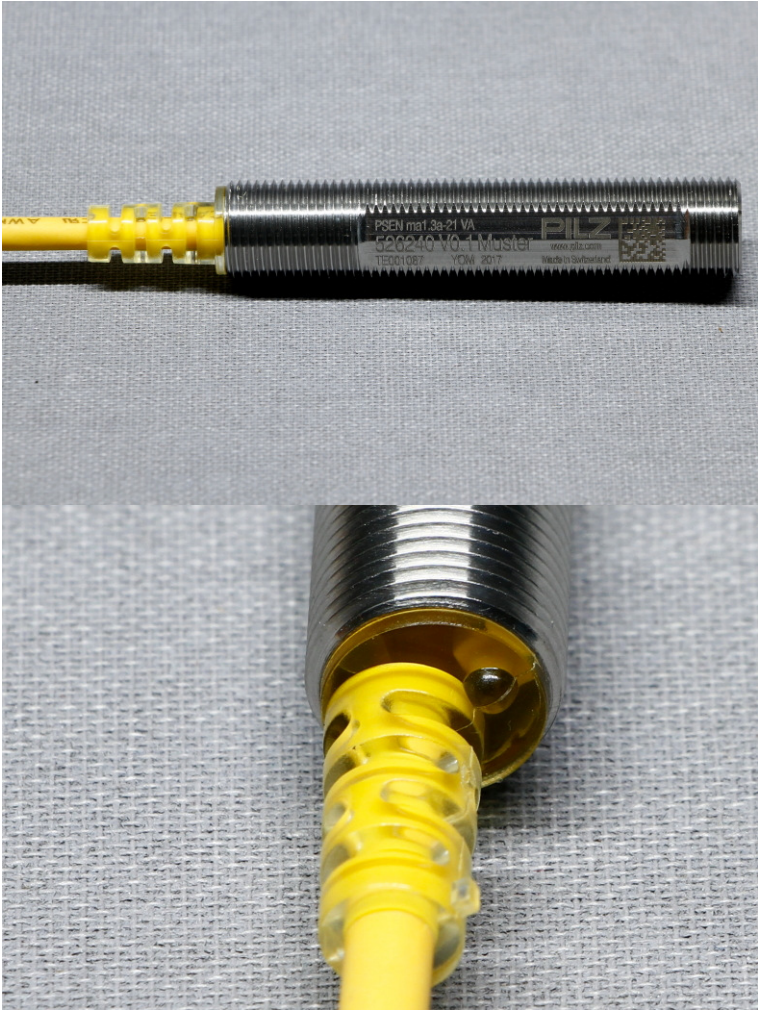
Table 8: P3-topactive 500

| Test medium<br>(test solution) | P3-topactive 500 / 5% | Result - Remark |
|---|---|---|
| G/004.526240 | | <p>After 28 days:<br/>- No visible abnormalities at outer enclosure parts and cable</p> |

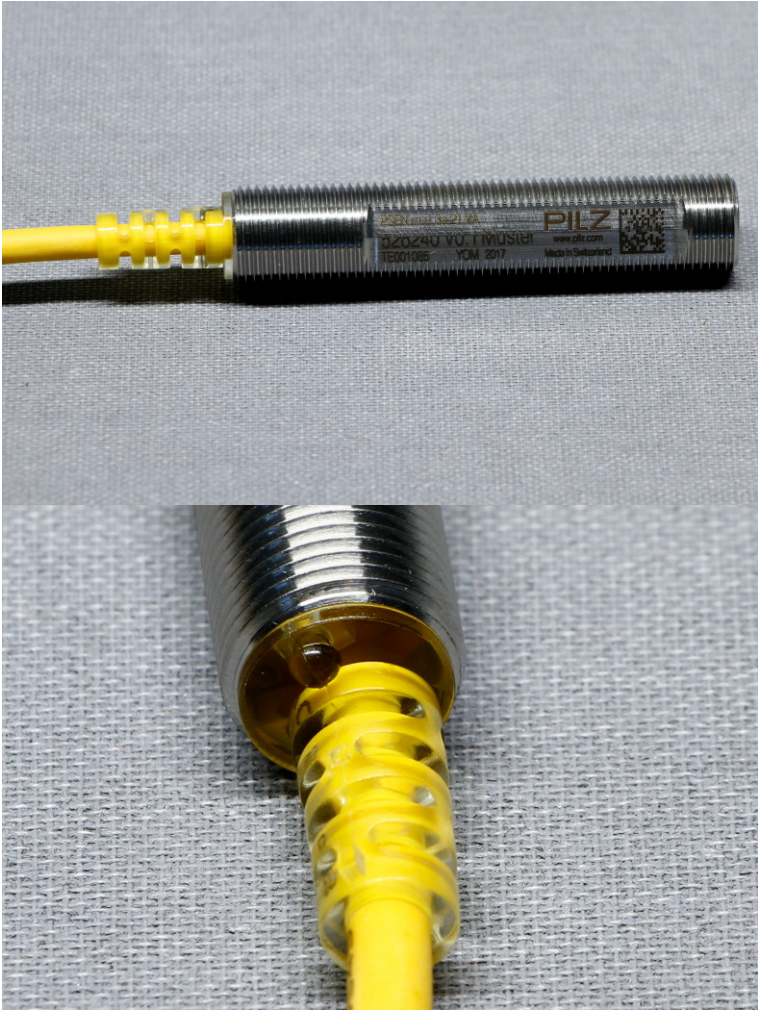
Table 9: P3-topax 990

| Test medium<br>(test solution) | P3-topax 990 / 3% | Result - Remark |
|---|---|---|
| G/005.526240 | | <p>After 28 days:</p> <ul style="list-style-type: none"> <li>- No visible abnormalities at outer enclosure parts and cable</li> </ul> |

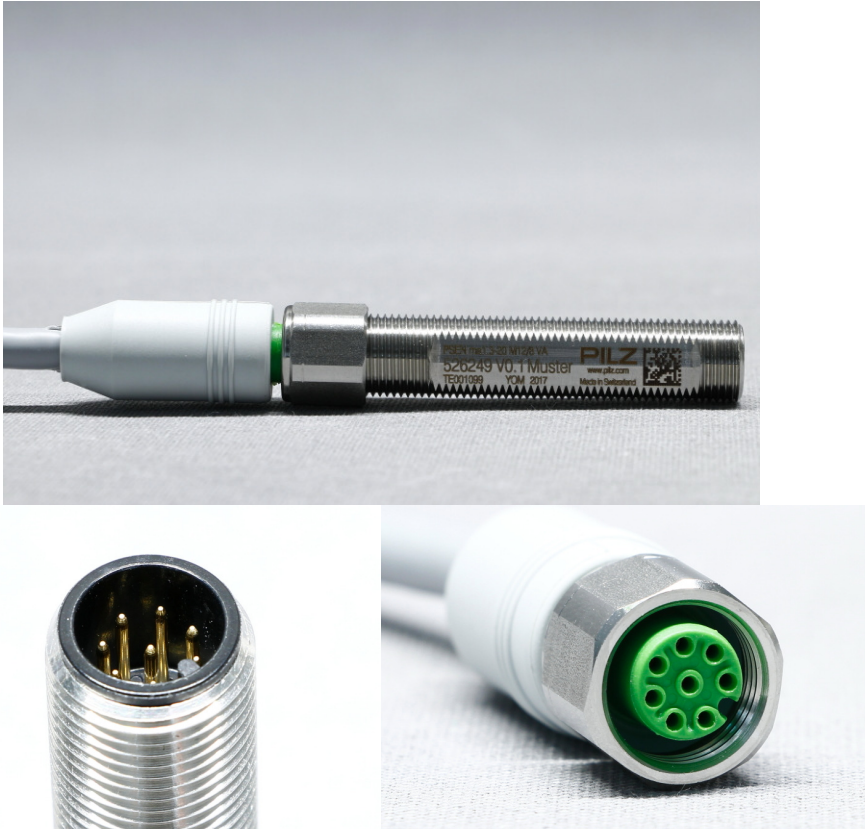
Table 10: test samples before testing

| Sample no. | Type reference: Stainless steel sensor PSEN ma1.3-20 M12/8VA (526249) | |
|---|---|---|
| | | Samples without abnormalities. |

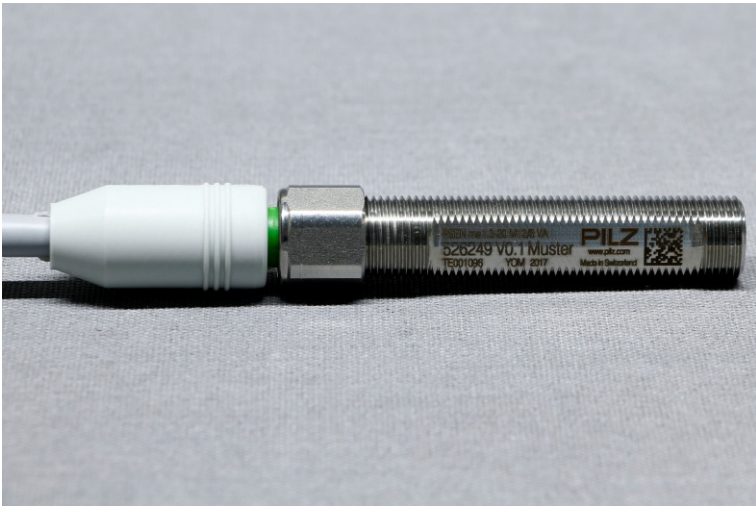
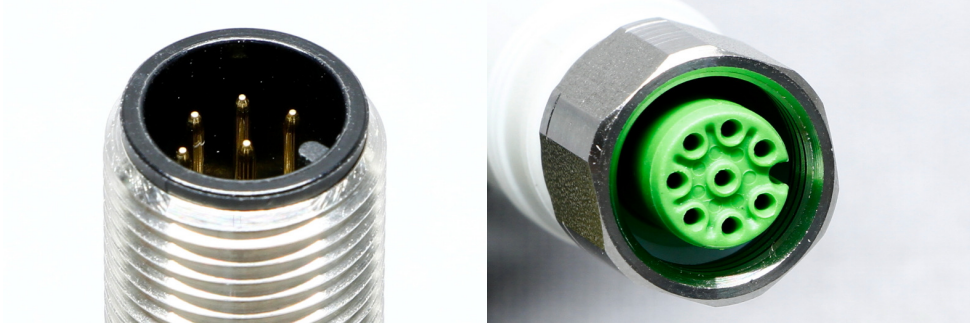
Table 11: Demineralized water

| Test medium<br>(test solution) | Demineralized water | | Result - Remark |
|---|---|--|---|
| G/006.526249 | <br> | | <p>After 28 days:</p> <ul style="list-style-type: none"><li>- No visible abnormalities at outer enclosure parts and cable</li></ul> |

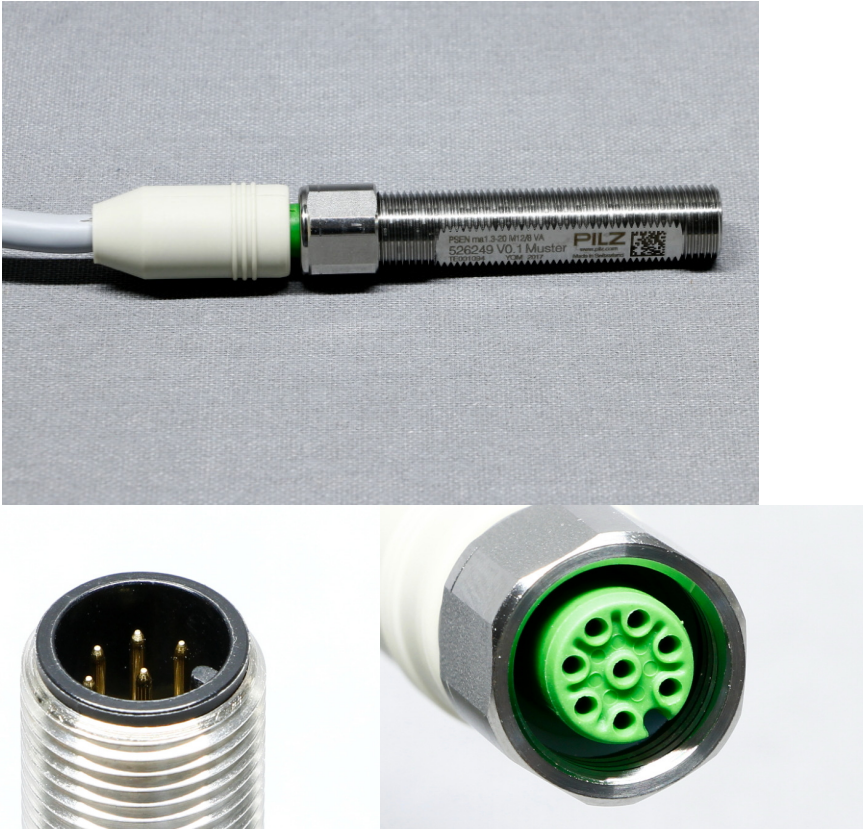
Table 12: P3-topactive OKTO

| Test medium<br>(test solution) | P3-topactive OKTO / 1% | | Result - Remark |
|---|---|--|---|
| G/001.526249 | | | <p>After 28 days:</p> <ul style="list-style-type: none"><li>- No visible abnormalities at outer enclosure parts and cable</li></ul> |

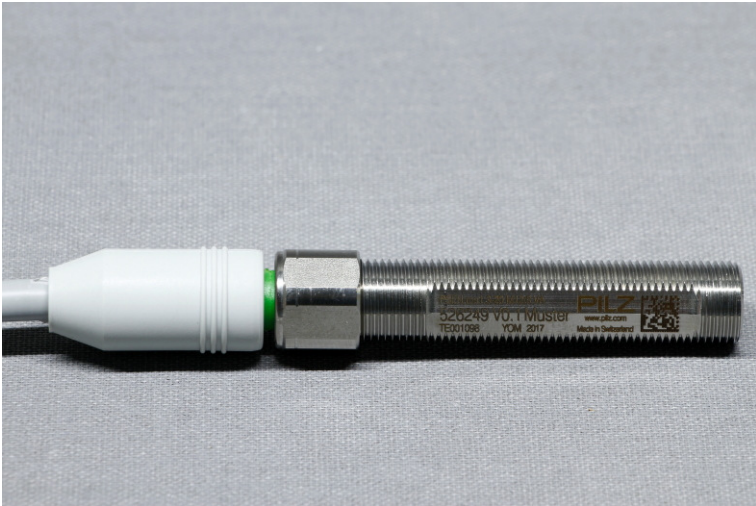
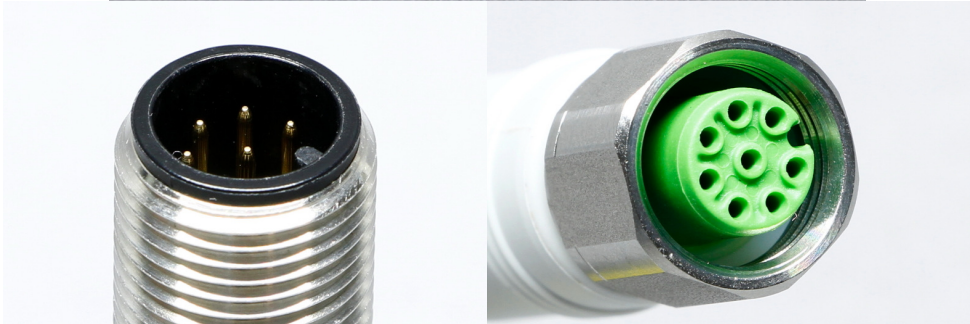
Table 13: P3-topax 66

| Test medium<br>(test solution) | P3-topax 66 / 5% | | Result - Remark |
|---|---|--|---|
| G/002.526249 | <br> | | <u>After 28 days:</u><br>- No visible abnormalities at outer enclosure parts and cable |

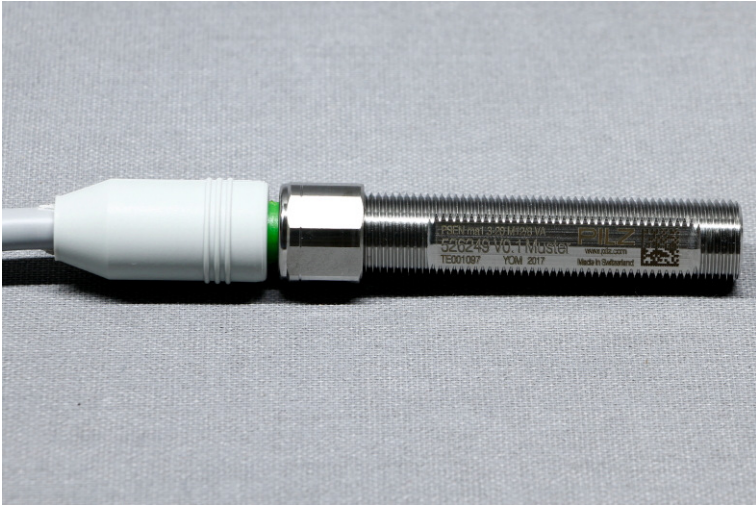
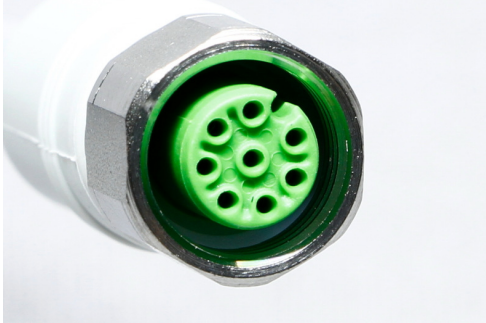
**Table 14: P3-topactive 200**

| Test medium<br>(test solution) | <i>P3-topactive 200 / 5%</i> | Result - Remark |
|---|---|---|
| G/003.526249 | | <p><u>After 28 days:</u></p> <ul style="list-style-type: none"> <li>- No visible abnormalities at outer enclosure parts and cable</li> </ul> |

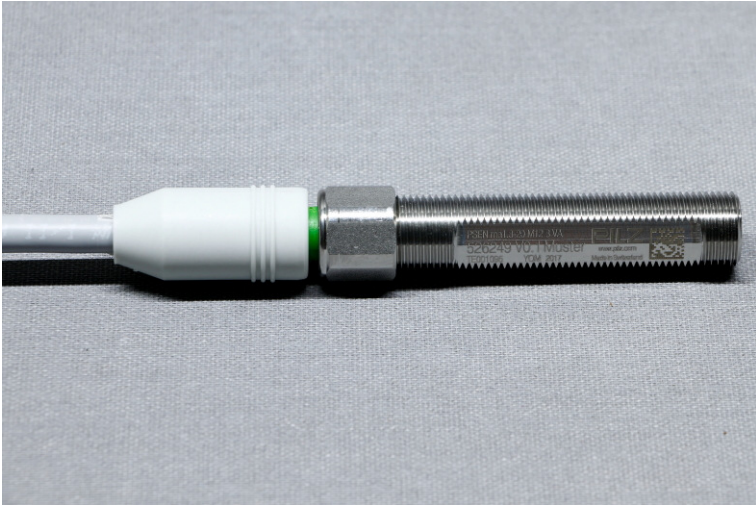
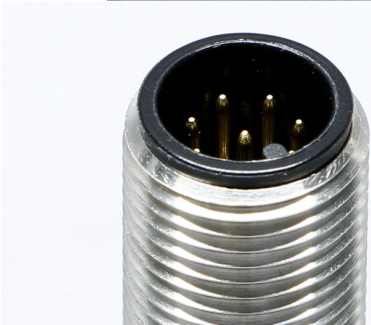
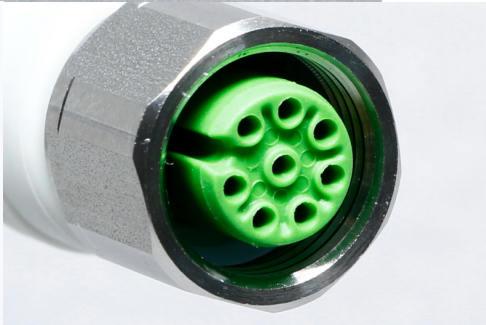
**Table 15: P3-topactive 500**

| Test medium<br>(test solution) | P3-topactive 500 / 5% | Result - Remark |
|---|---|---|
| G/004.526249 | | <p>After 28 days:</p> <ul style="list-style-type: none"> <li>- No visible abnormalities at outer enclosure parts and cable</li> </ul> |

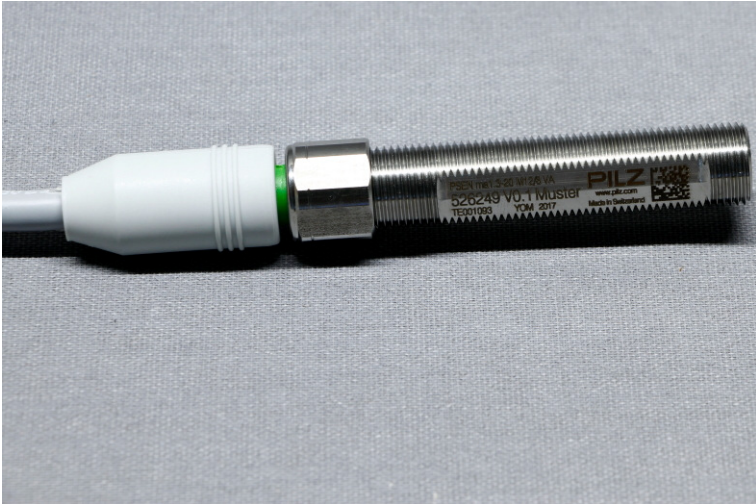
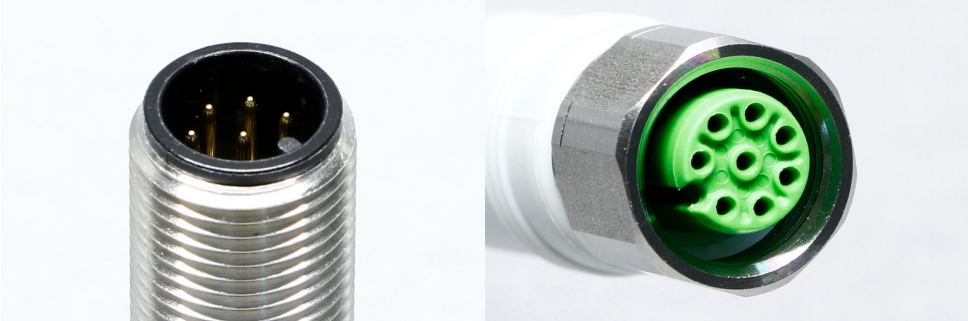
Table 16: P3-topax 990

| Test medium<br>(test solution) | P3-topax 990 / 3% | Result - Remark |
|---|---|---|
| G/005.526249 | | <p>After 28 days:</p> <ul style="list-style-type: none"> <li>- No visible abnormalities at outer enclosure parts and cable</li> </ul> |

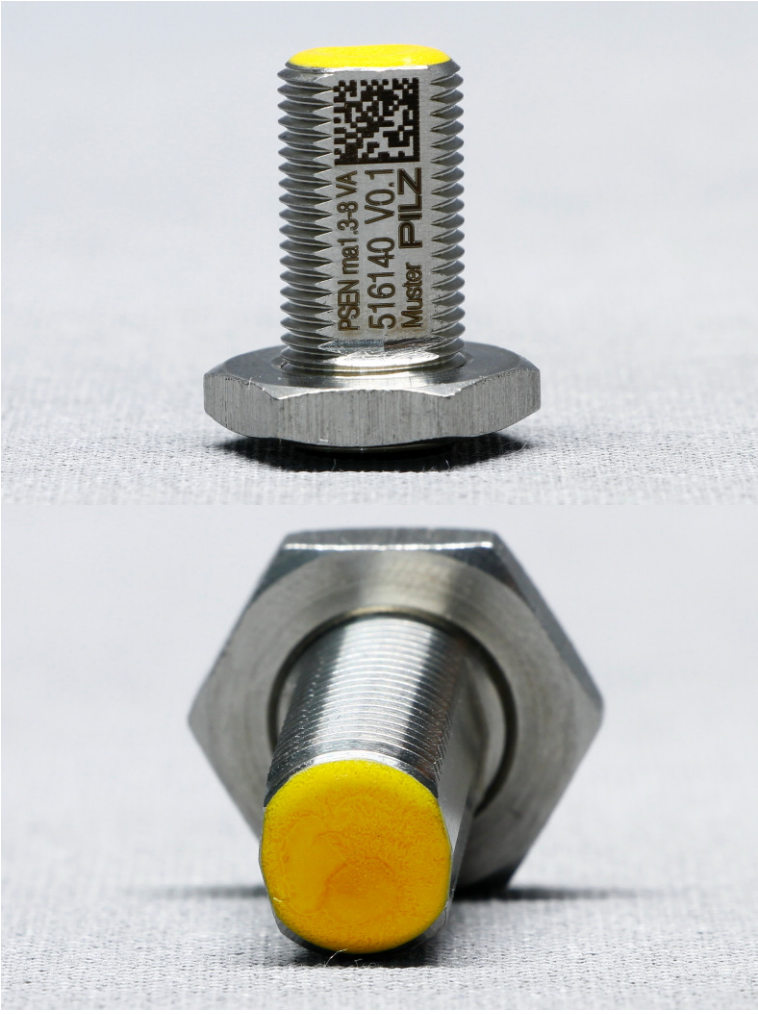
Table 17: test samples before testing

| Sample no. | Type reference: Stainless steel actuator PSEN ma1.3-8VA (516140) | | |
|---|---|---|---|
| G/001..006.<br>516140 | | | Samples without abnormalities. |

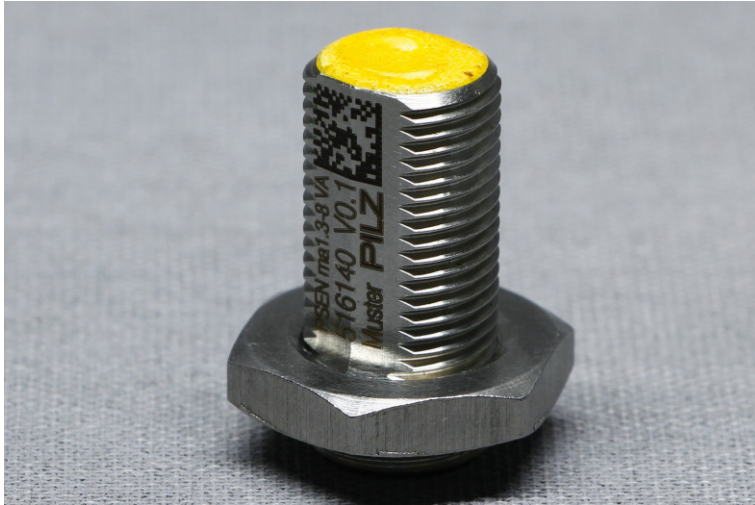
**Result of visual check after the test (PSEN ma1.3-8VA (516140))****Table 18: Demineralized water**

| Test medium<br>(test solution) | Demineralized water | | Result - Remark |
|---|---|---|---|
| G/006.516140 | | | <u>After 28 days:</u><br>- No visible abnormalities at outer enclosure parts |

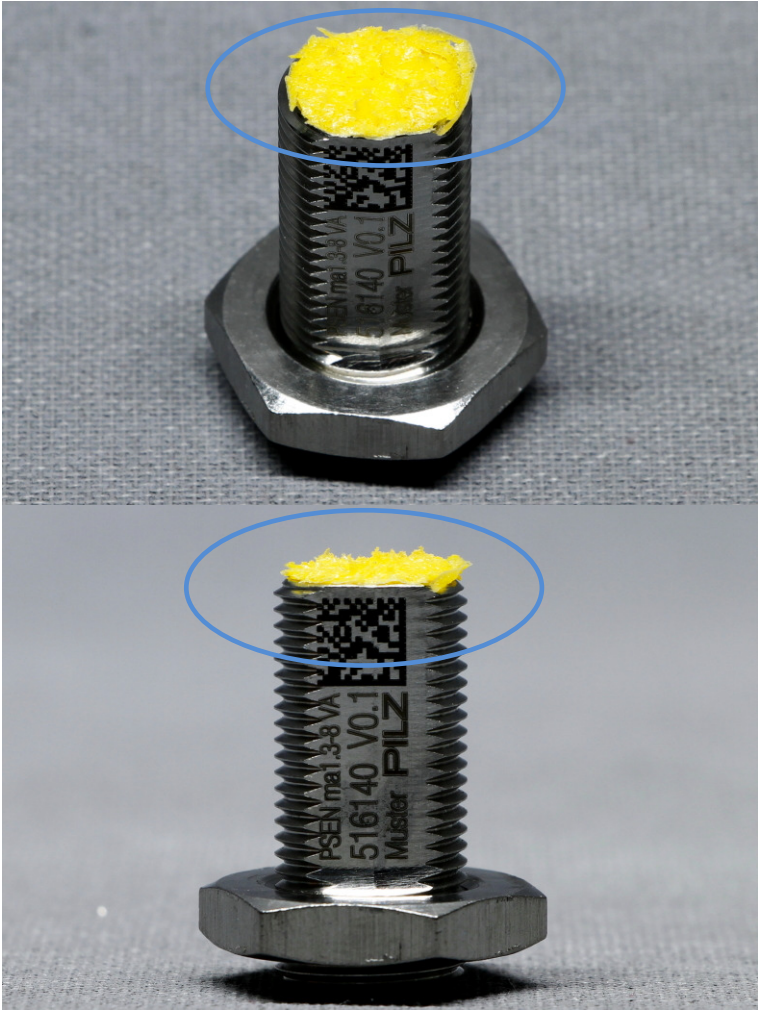
Table 19: P3-topactive OKTO

| Test medium<br>(test solution) | P3-topactive OKTO / 1% | Result - Remark |
|---|---|---|
| G/001.516140 | | <p>After 28 days:</p> <ul style="list-style-type: none"> <li>- A slight visible abnormality at outer enclosure parts</li> </ul> <p>(Blue mark: "blooming" of the potting compound, no visible abnormalities or particles in the test liquid. Not relevant for the test.)</p> |

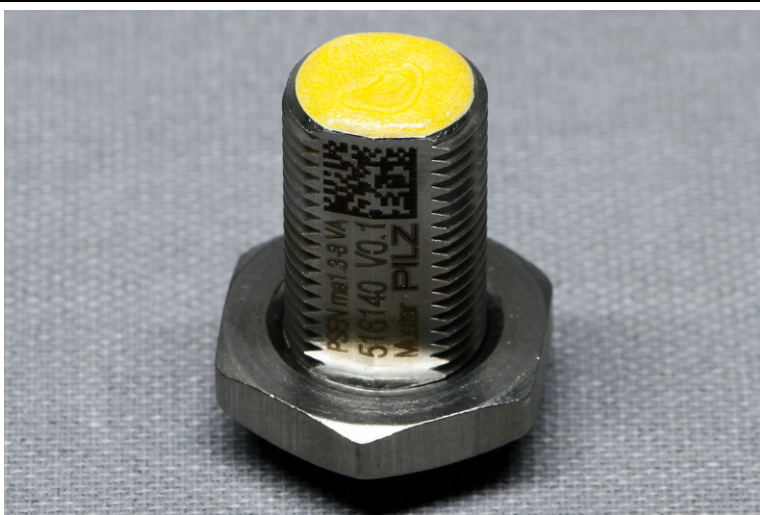
**Table 20: P3-topax 66**

| Test medium<br>(test solution) | <b>P3-topax 66 / 5%</b> | | Result - Remark |
|---|---|---|---|
| G/002.516140 | | | <u>After 28 days:</u><br>- No visible abnormalities at outer enclosure parts |

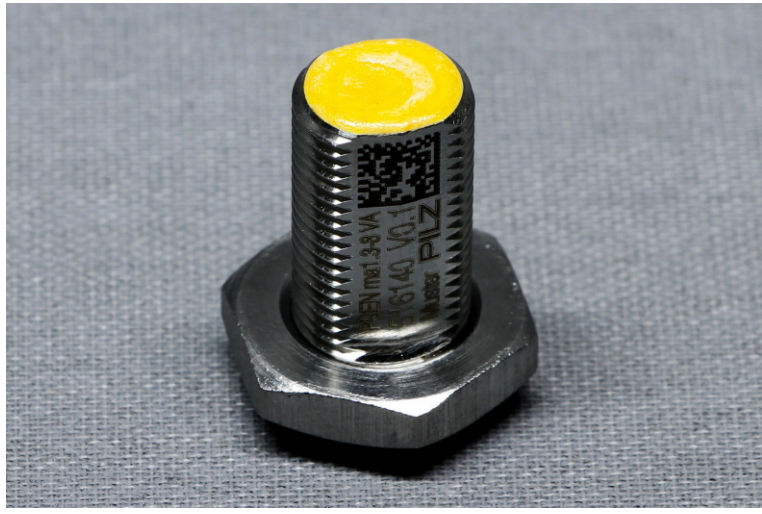
**Table 21: P3-topactive 200**

| Test medium<br>(test solution) | <b>P3-topactive 200 / 5%</b> | | Result - Remark |
|---|---|---|---|
| G/003.516140 | | | <p><u>After 28 days:</u></p> <ul style="list-style-type: none"> <li>- No visible abnormalities at outer enclosure parts</li> </ul> |

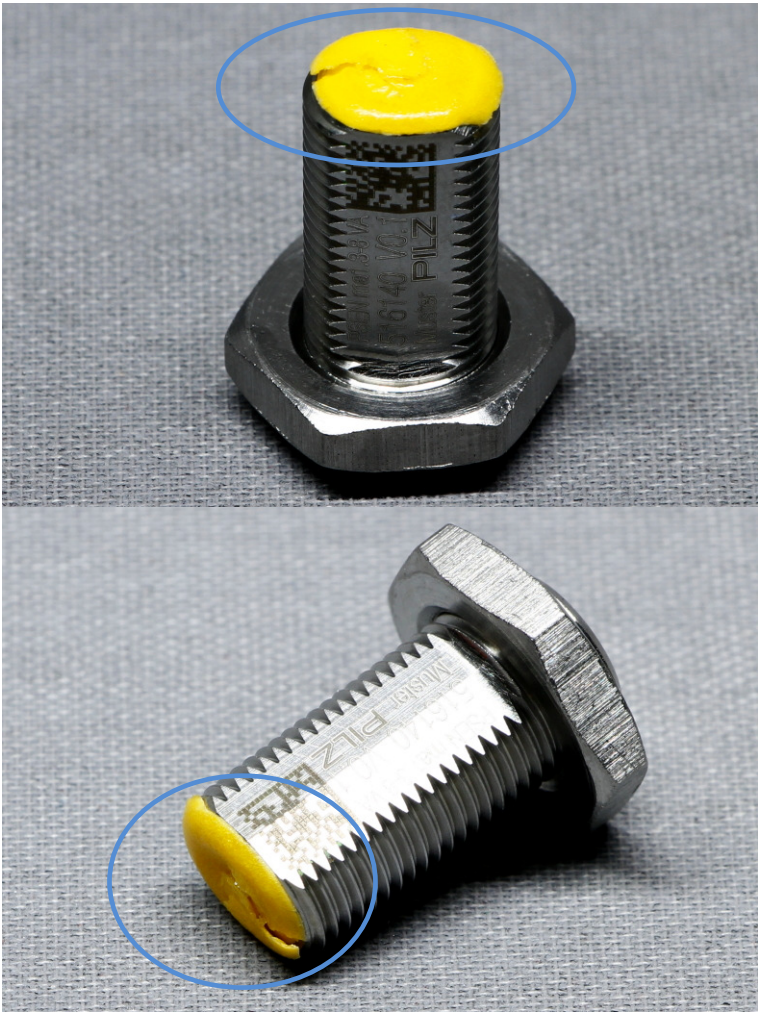
Table 22: P3-topactive 500

| Test medium<br>(test solution) | P3-topactive 500 / 5% | Result - Remark |
|---|---|---|
| G/004.516140 | | <p>After 28 days:</p> <ul style="list-style-type: none"> <li>- A slight visible abnormality at outer enclosure parts</li> </ul> <p>(Blue mark: Swelling and cracking in the potting compound, no visible abnormalities or particles in the test liquid. Not relevant for the test.)</p> |

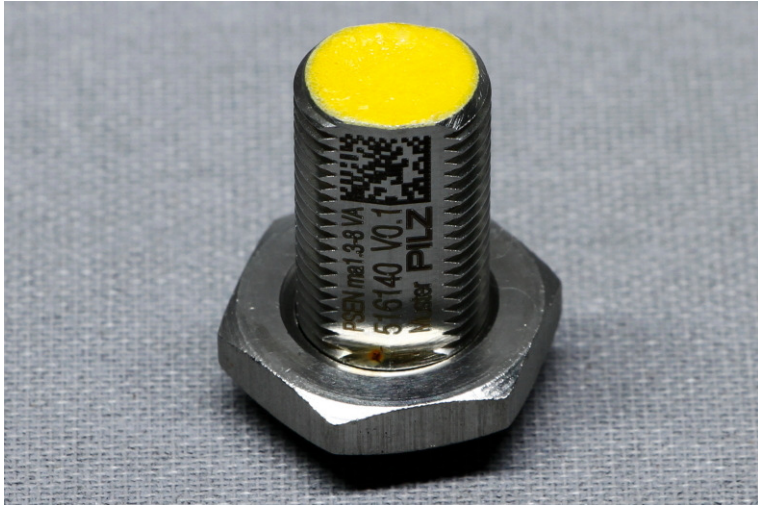
**Table 23: P3-topax 990**

| Test medium<br>(test solution) | <b>P3-topax 990 / 3%</b> | | Result - Remark |
|---|---|--|---|
| G/005.516140 | | | <u>After 28 days:</u><br>- No visible abnormalities at outer enclosure parts |
